Upgrading/ Improvement of Roadside Slope/
Retaining Walls on Hong Kong Island (2005-
2008 Programme) – Investigation, Design and
Construction

Heritage Impact Assessment Report for Feature No. 11SW-B/R93 (Sub- division 1), Duddell Street

Report Ref: M45/200

Final | June 2013

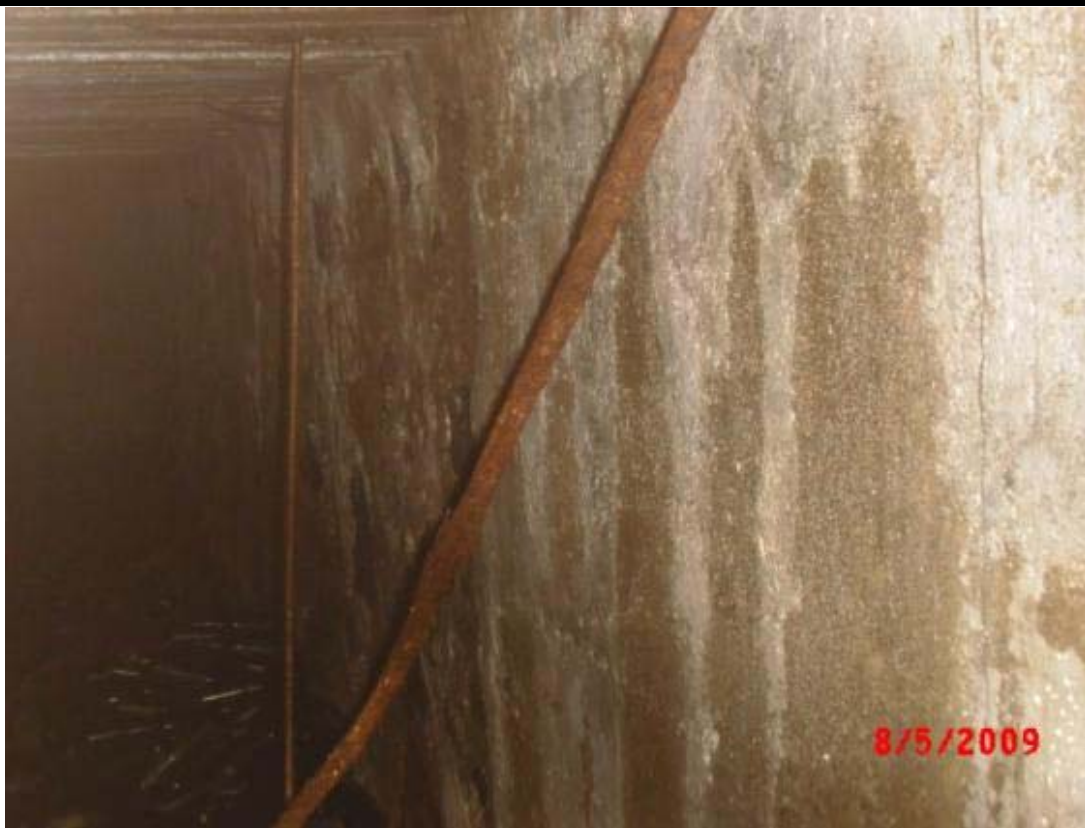
Subject Disused tunnel connected to Portal 44 (Plate 61) **Date photograph taken** 08-May-09

Description Row of flat precast reinforced concrete lintels is observed at the ceiling

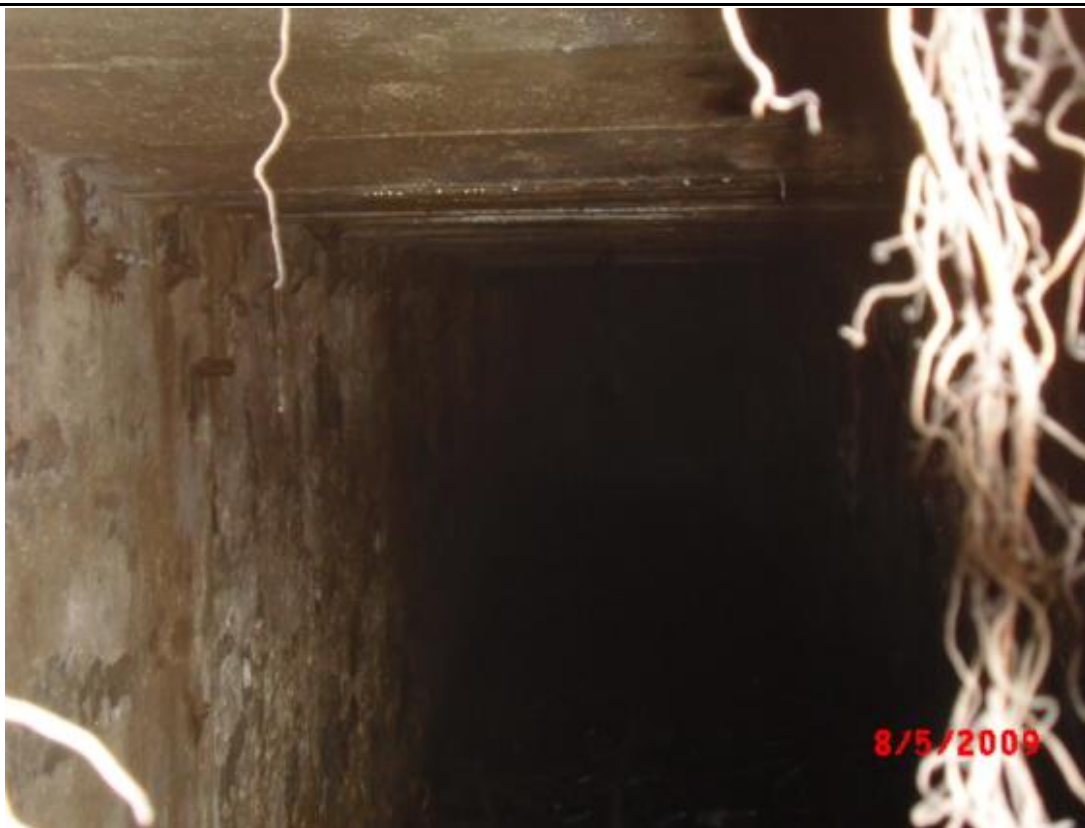
Subject Disused tunnel connected to Portal 44 (Plate 62) **Date photograph taken** 08-May-09

Description Row of flat precast reinforced concrete lintels is observed at the ceiling

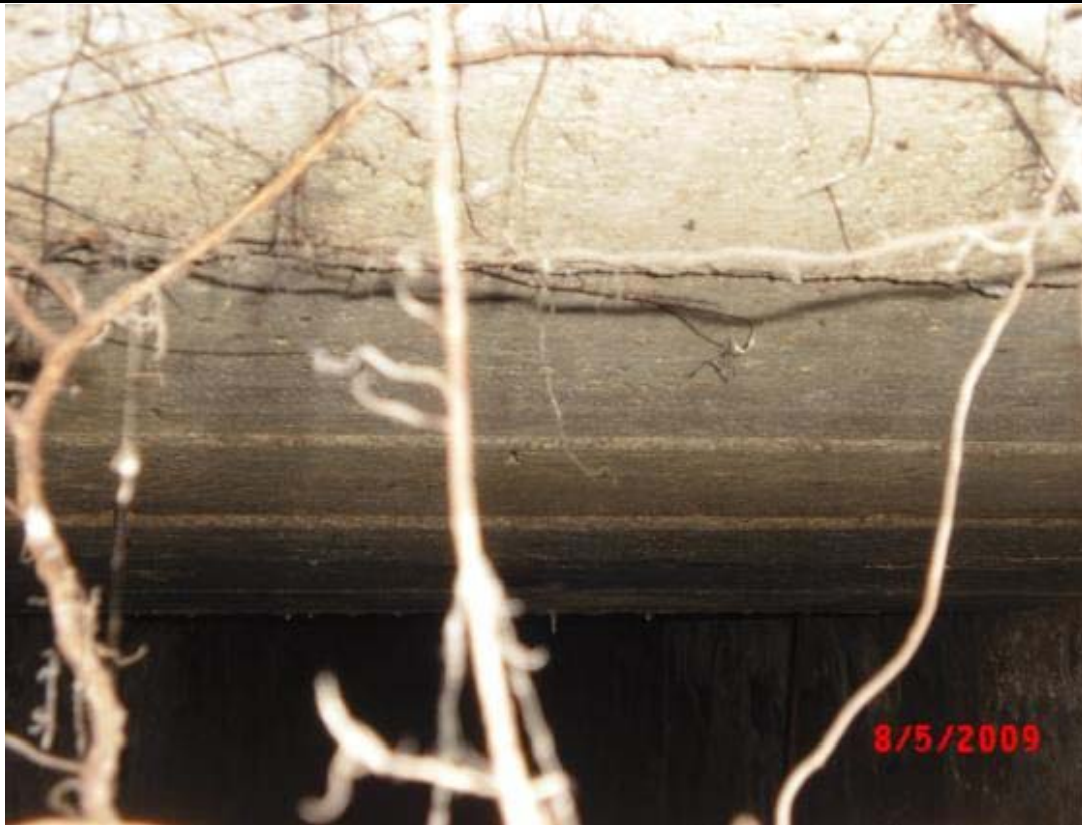
Subject Disused tunnel connected to Portal 44 (Plate 63) **Date photograph taken** 08-May-09

Description Tree roots are growing along the ceiling inside the tunnel

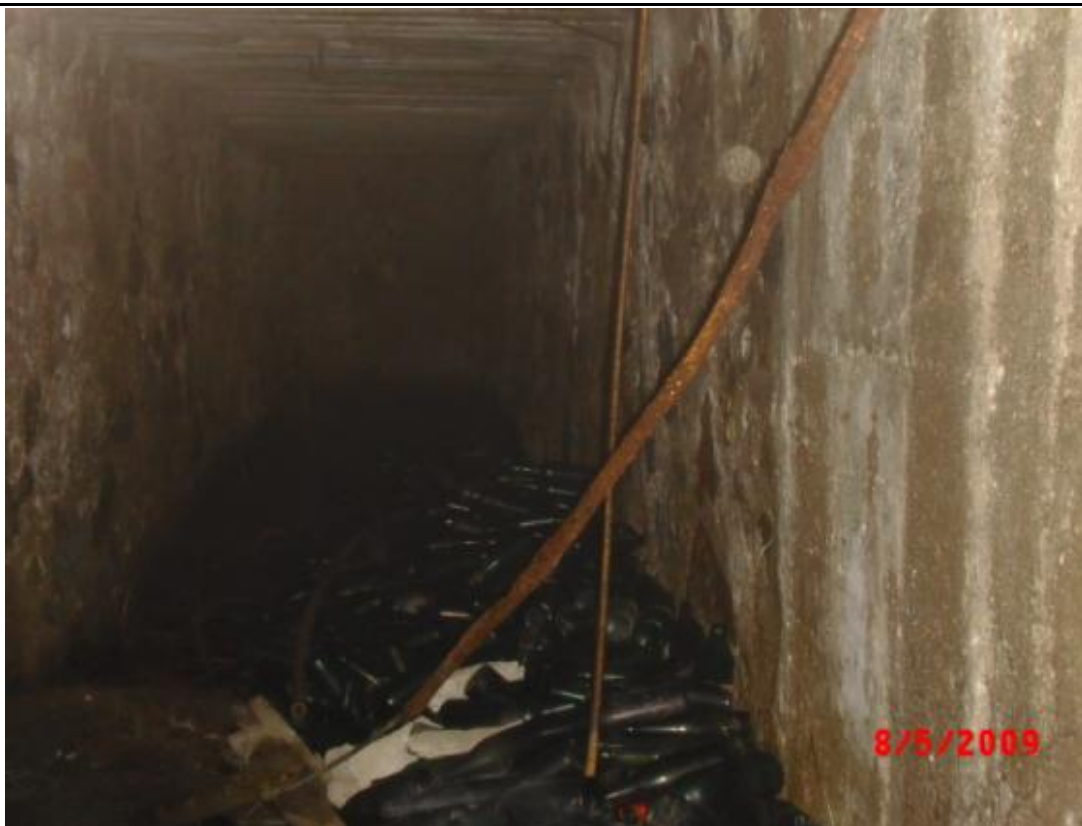
Subject Disused tunnel connected to Portal 44 (Plate 64) **Date photograph taken** 08-May-09

Description Lots of empty glass bottles are placed on the floor

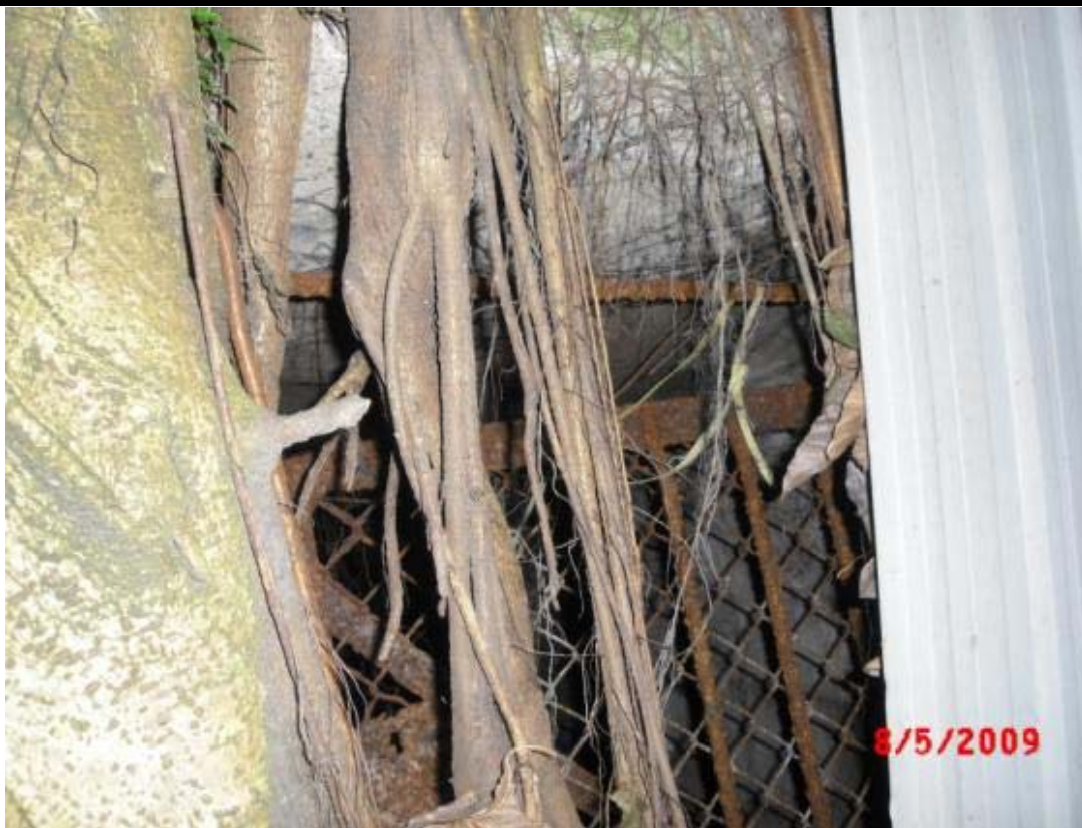
Subject Feature No. 11SW-B/R93 (Plate 65) **Date photograph taken** 08-May-09

Description The entrance of th tunnel is blocked by tree roots

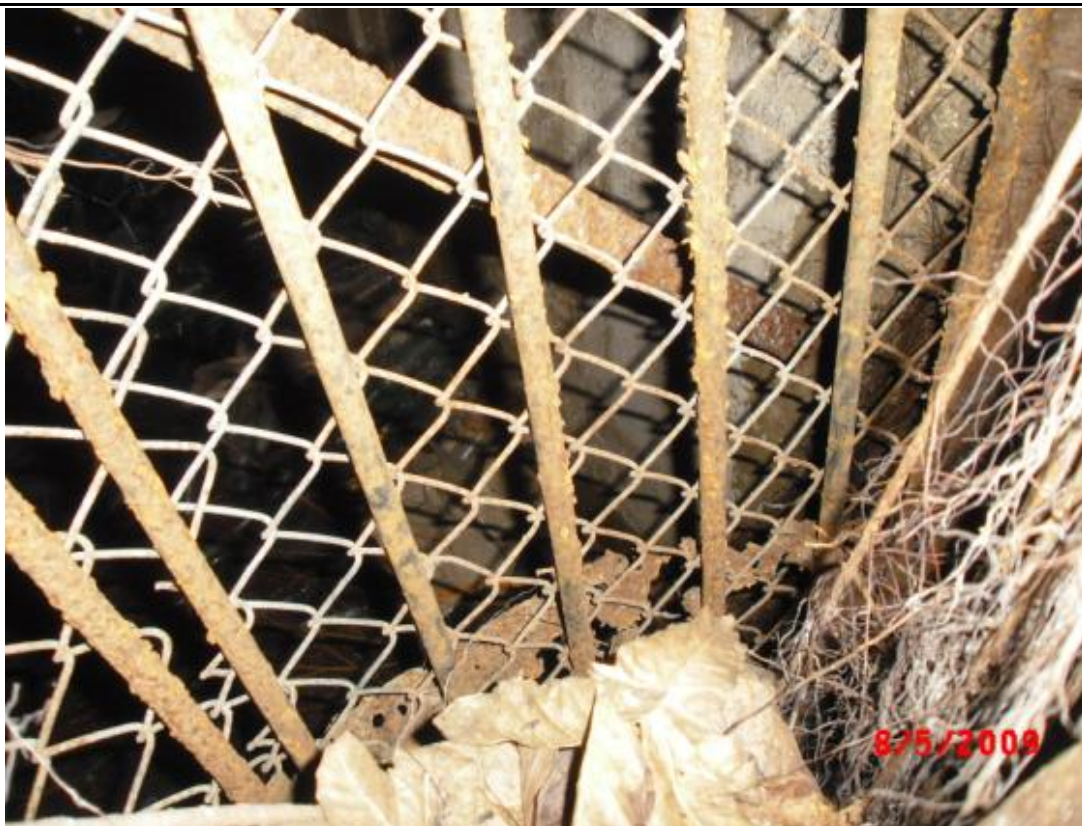
Subject Feature No. 11SW-B/R93 (Plate 66) **Date photograph taken** 08-May-09

Description The steel gate is corroded and in poor condition

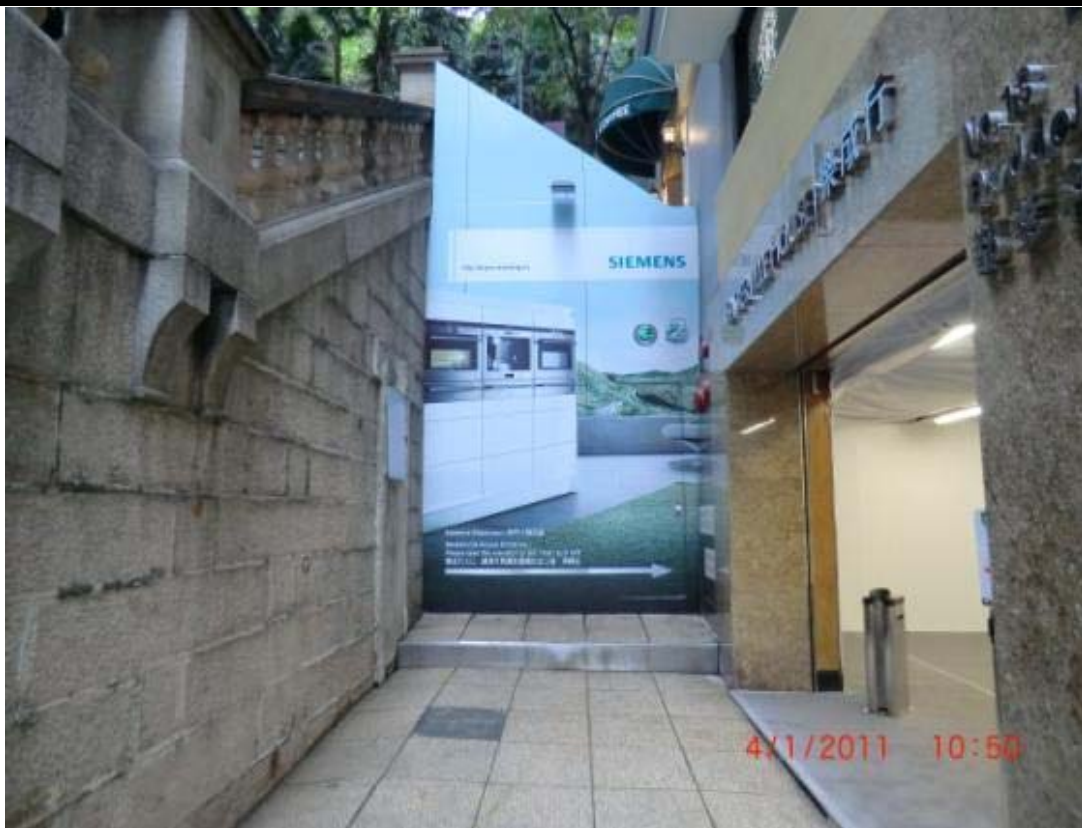
Subject Adjacent buildings - Baskerville House (Plate 67) **Date photograph taken** 04-Jan-11

Description A trapezoid steel gate is constructed adjacent to Backerville House

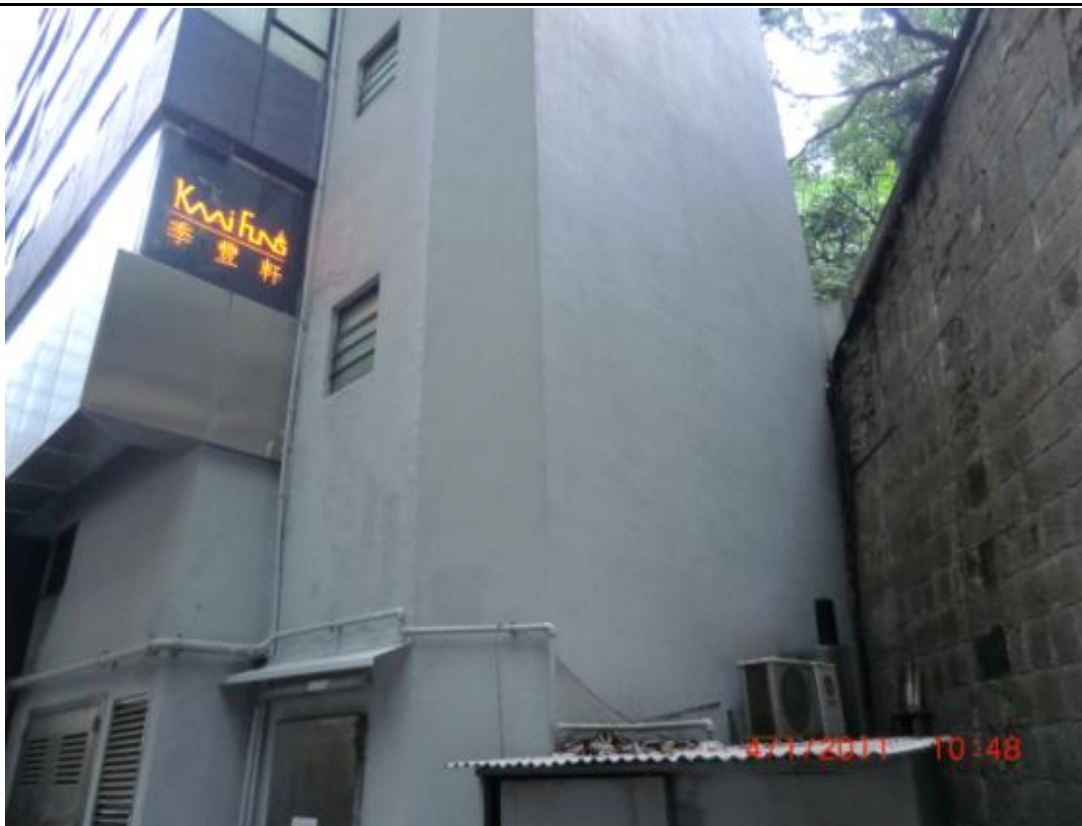
Subject Adjacent buildings - HKDEB (Plate 68) **Date photograph taken** 04-Jan-11

Description The condition of Hong Kong Diamond Exchange Building is good

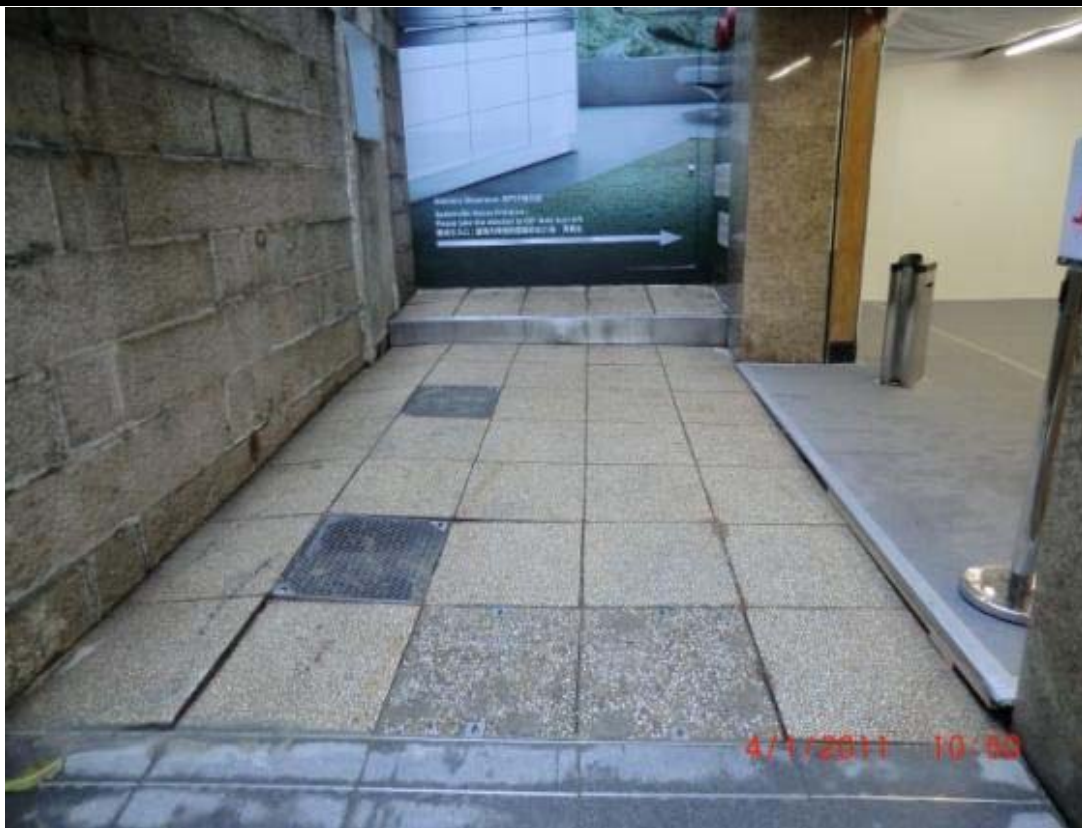
Subject Adjacent footpath/ pavement (Plate 69) **Date photograph taken** 04-Jan-11

Description View showing the footpath/ pavement adjacent to Baskerville House in good conditions

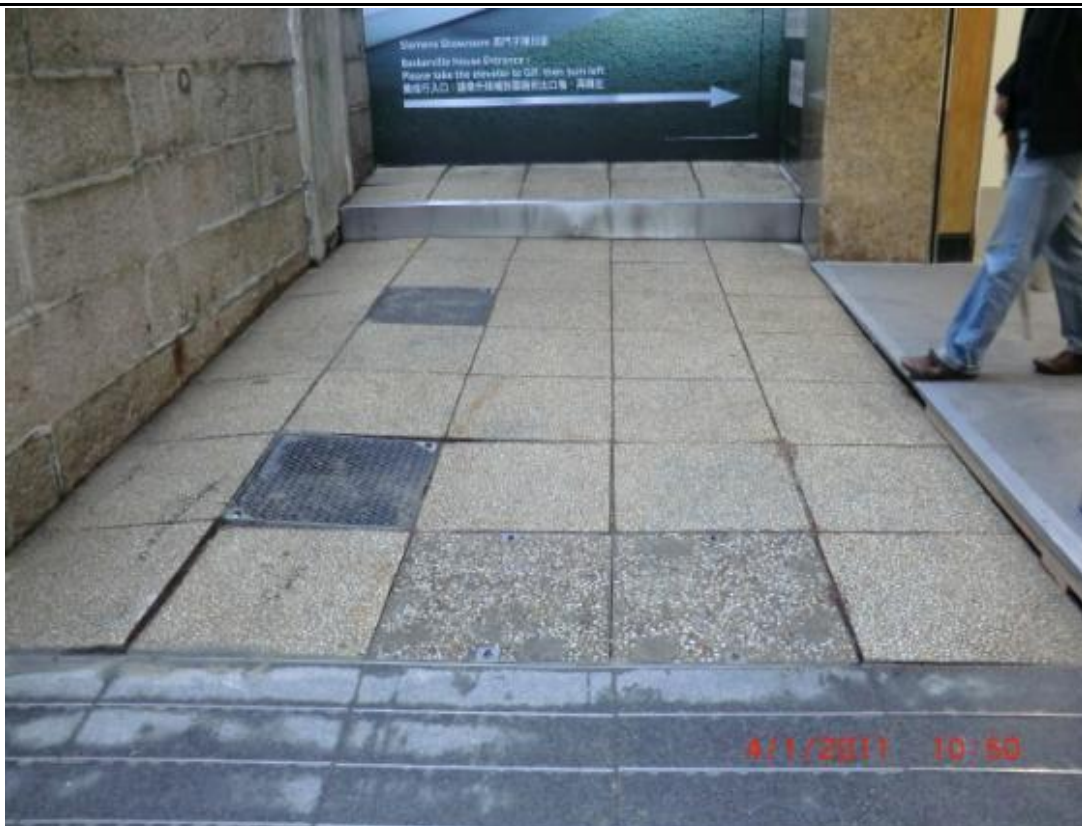
Subject Adjacent footpath/ pavement (Plate 70) **Date photograph taken** 04-Jan-11

Description A tread is constructed in front of the trapezoid steel gate

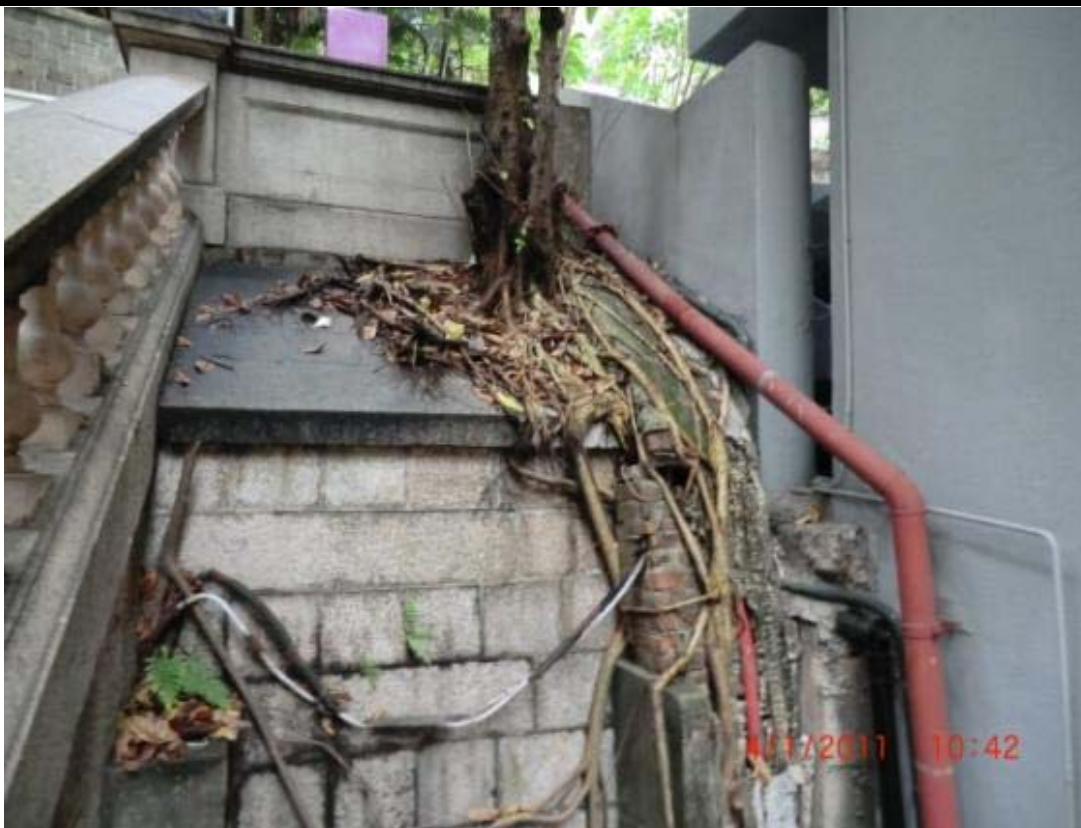
Subject Existing utilities on the surface of the Feature (Plate 71) **Date photograph taken** 04-Jan-11

Description View showing numerous of utilities are installed on the north-western wall surface

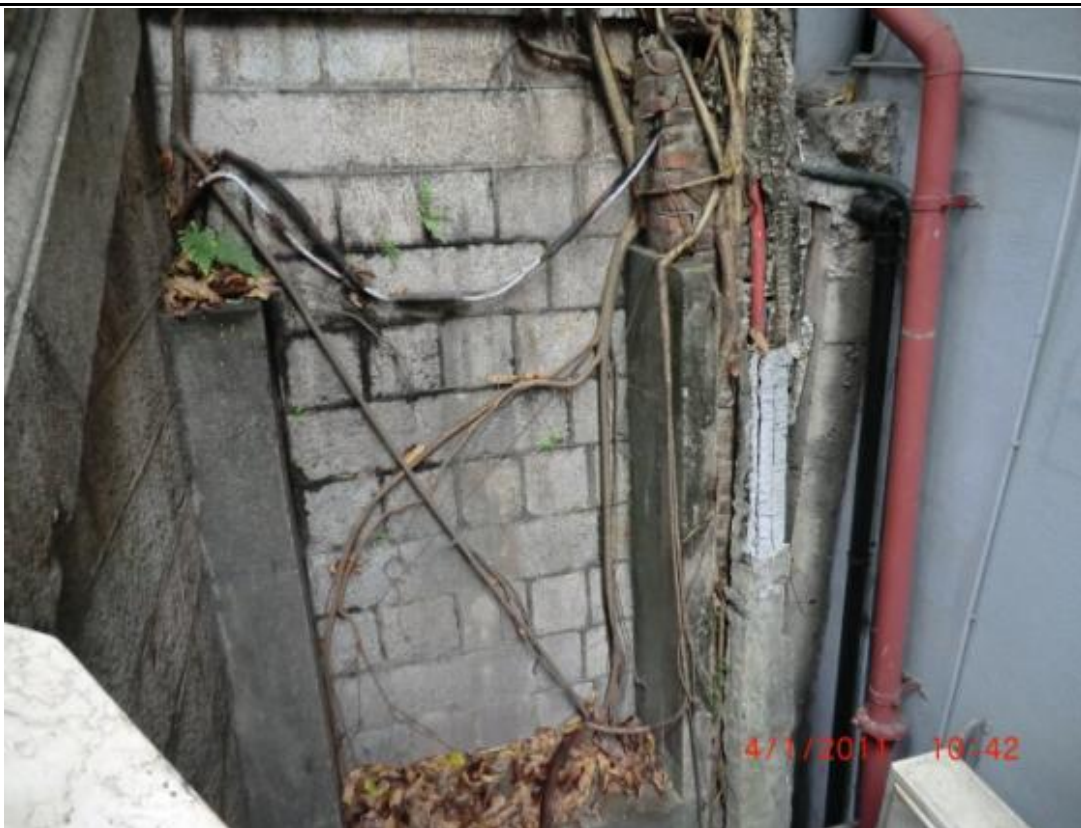
Subject Existing utilities on the surface of the Feature (Plate 72) **Date photograph taken** 04-Jan-11

Description The brick wall covering some of the utilities are broken

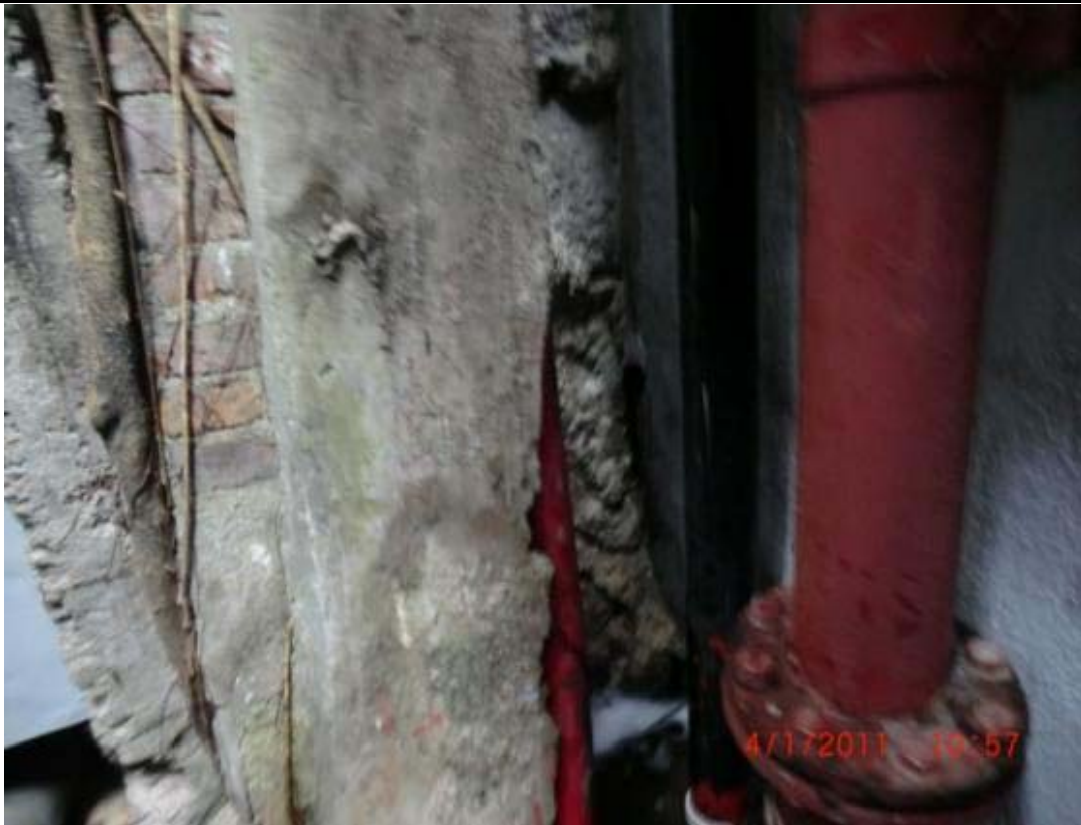
Subject Existing utilities on the surface of the Feature (Plate 73) **Date photograph taken** 04-Jan-11

Description Some utilities are constructed on the Feature and the exterior of Baskerville House

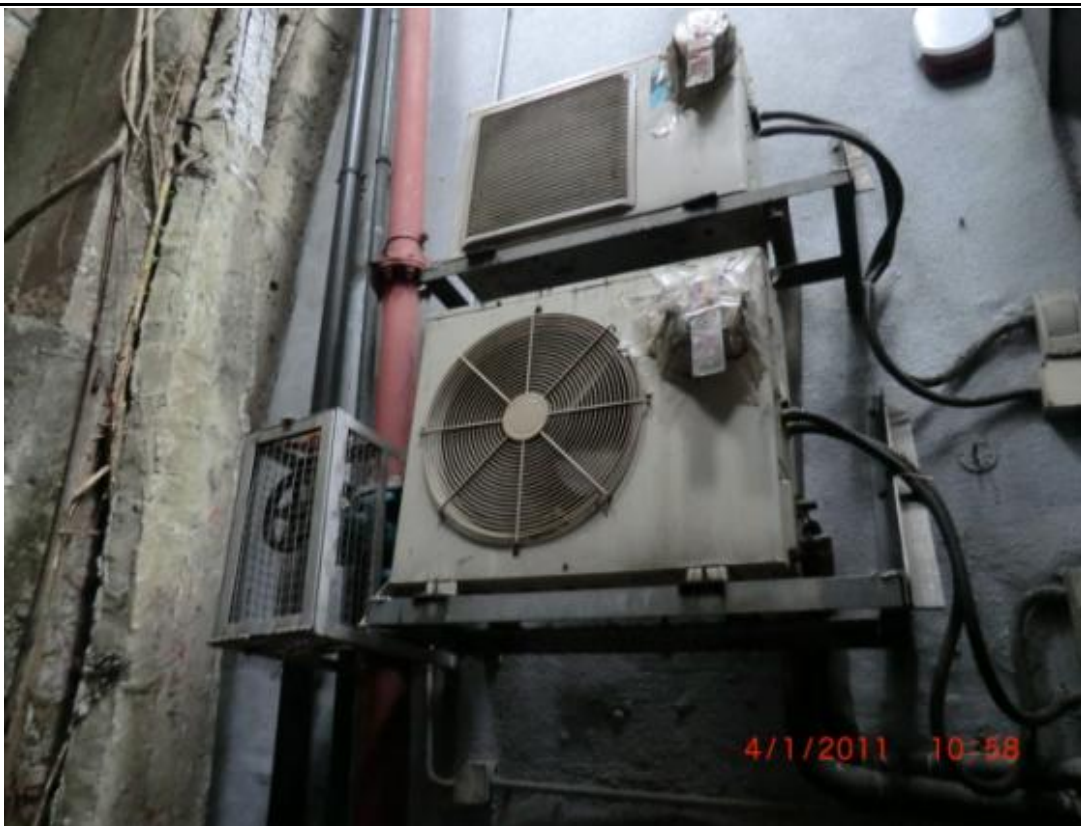
Subject Existing utilities on the surface of the Feature (Plate 74) **Date photograph taken** 04-Jan-11

Description Some air conditioners are installed on the exterior of Baskerville House

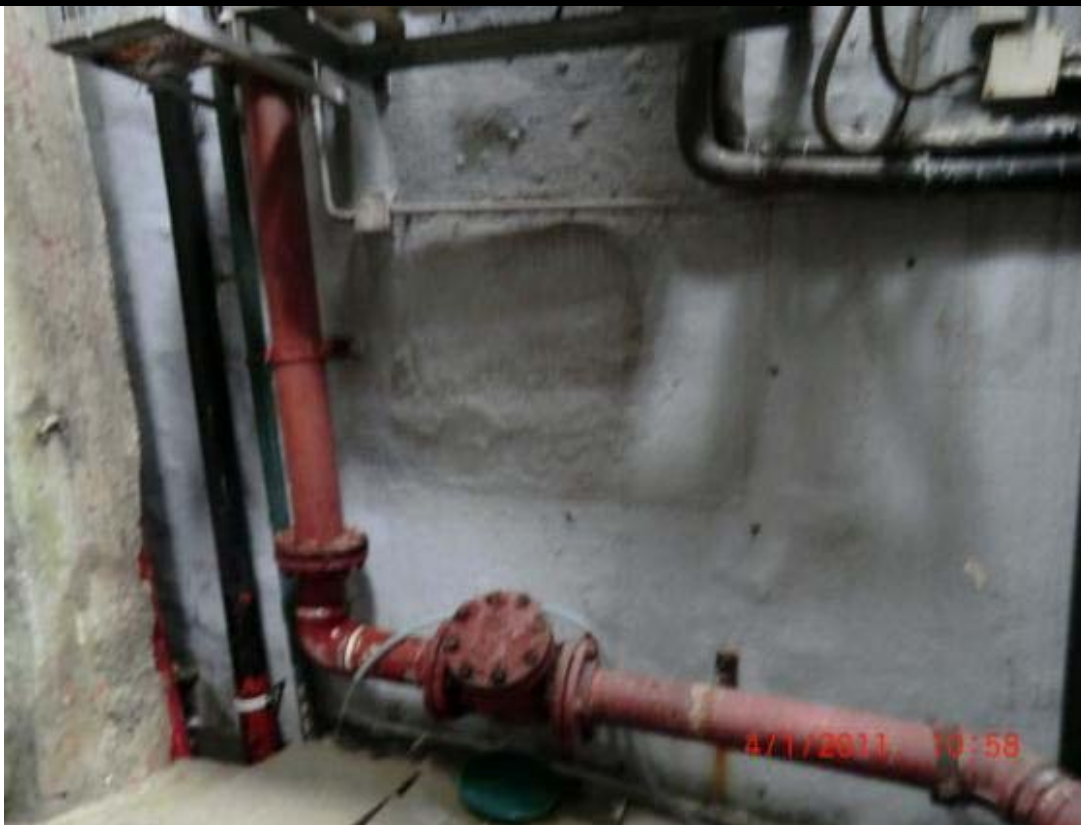
Subject Existing utilities on the surface of the Feature (Plate 75) **Date photograph taken** 04-Jan-11

Description Some of the utilities are connected to the toe of the Feature

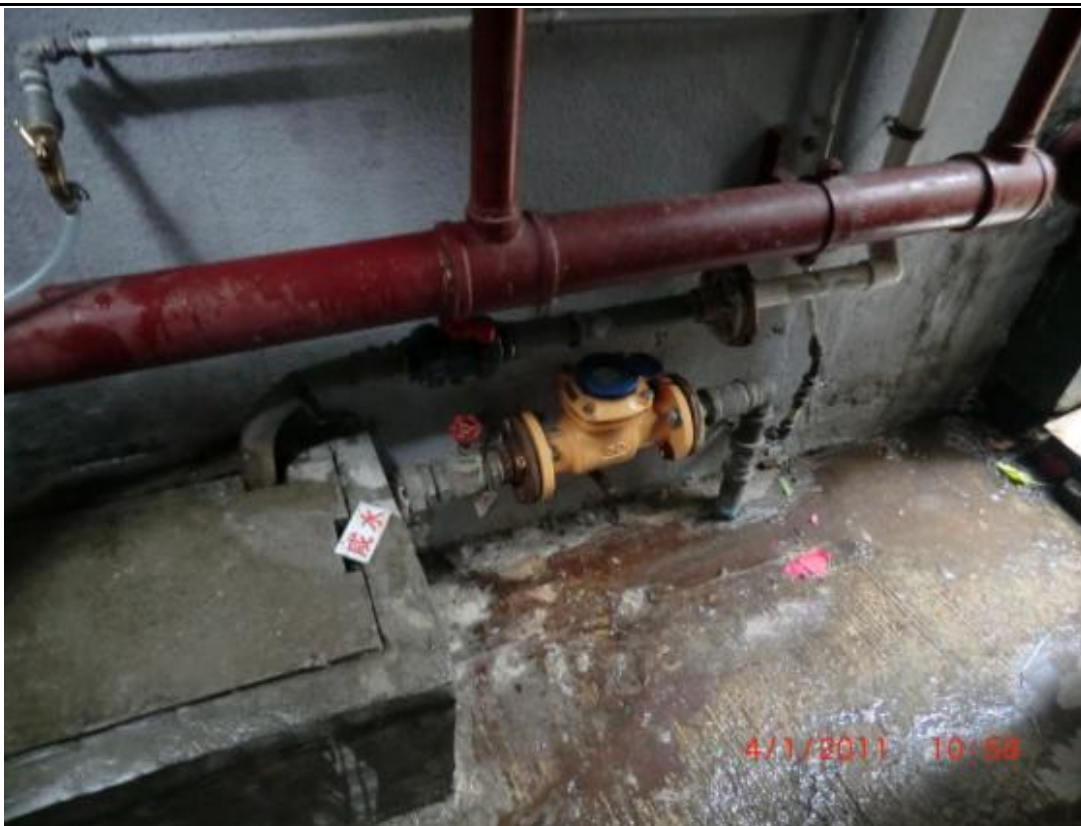
Subject Existing utilities on the surface of the Feature (Plate 76) **Date photograph taken** 04-Jan-11

Description Some of the utilities are connected to the toe of the Feature

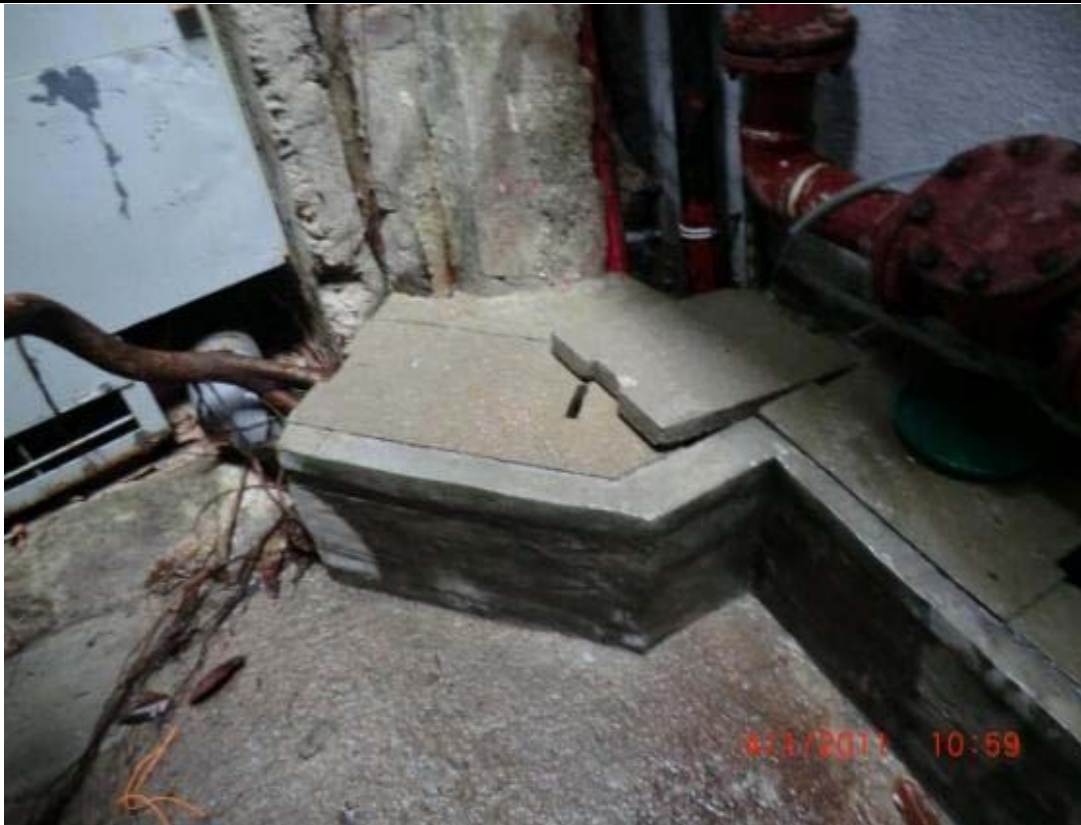
Subject Existing utilities on the surface of the Feature (Plate 77) **Date photograph taken** 04-Jan-11

Description A box channel is constructed at the Feature toe connected to a PVC from the tunnel

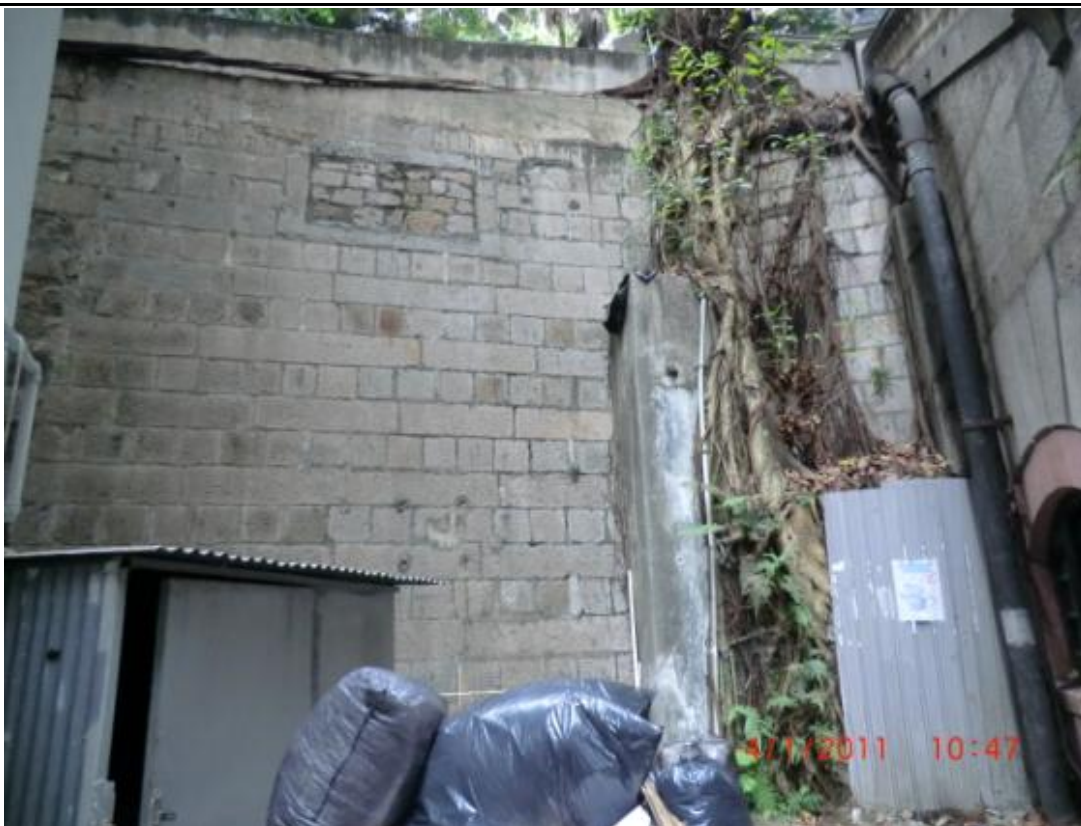
Subject Existing utilities on the surface of the Feature (Plate 78) **Date photograph taken** 04-Jan-11

Description View showing numerous of utilities are installed on the south-western wall surface

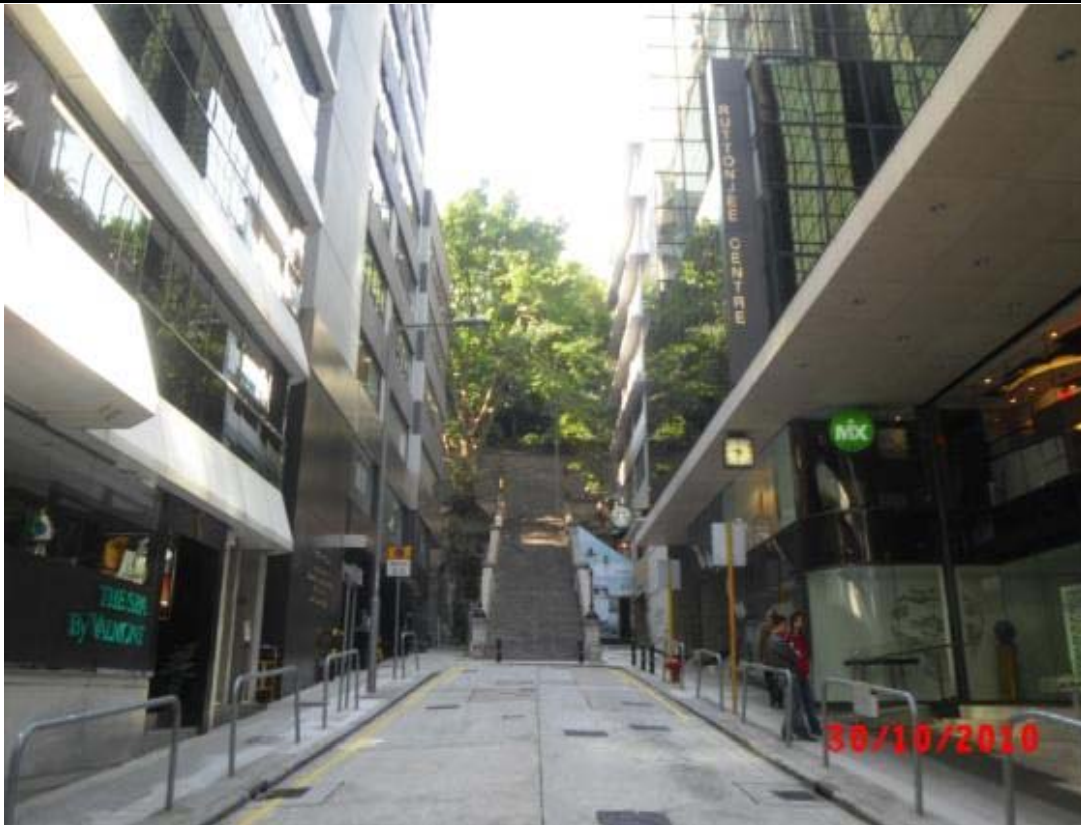
Subject Existing wall trees (Plate 79) **Date photograph taken** 30-Oct-10

Description General view of the declared monuments and wall trees

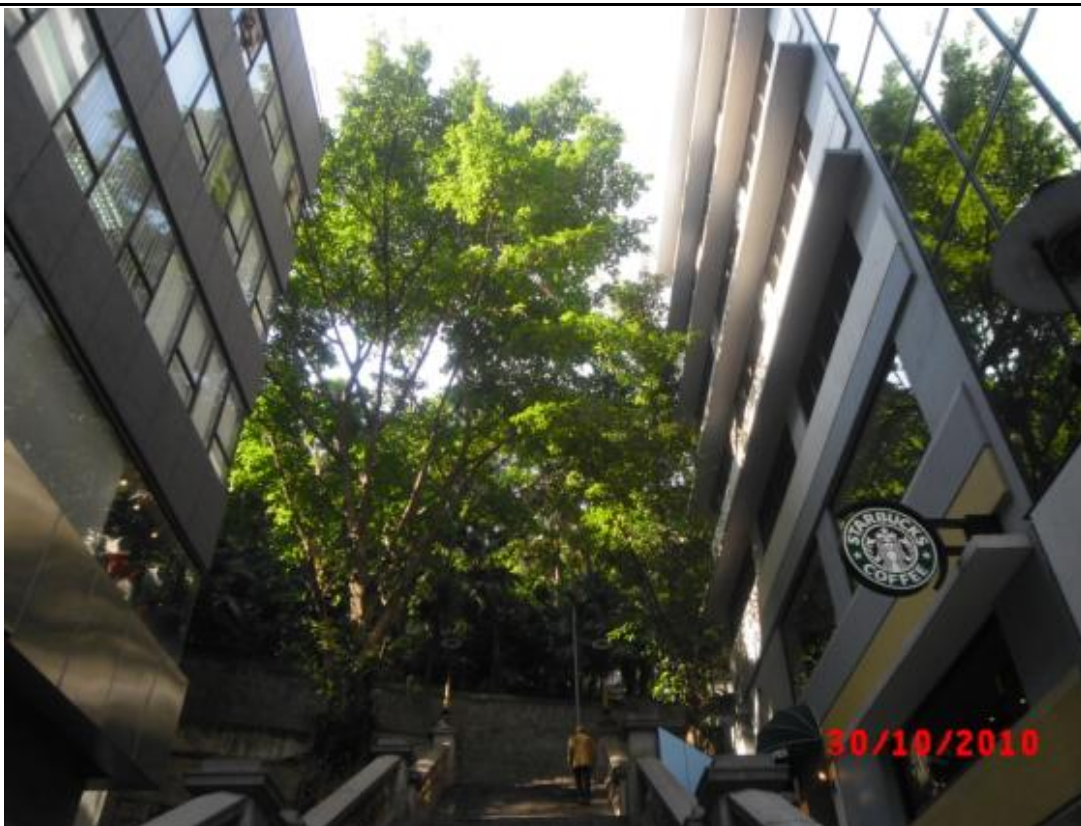
Subject Existing wall trees (Plate 80) **Date photograph taken** 30-Oct-10

Description View showing the existing conditions of wall trees

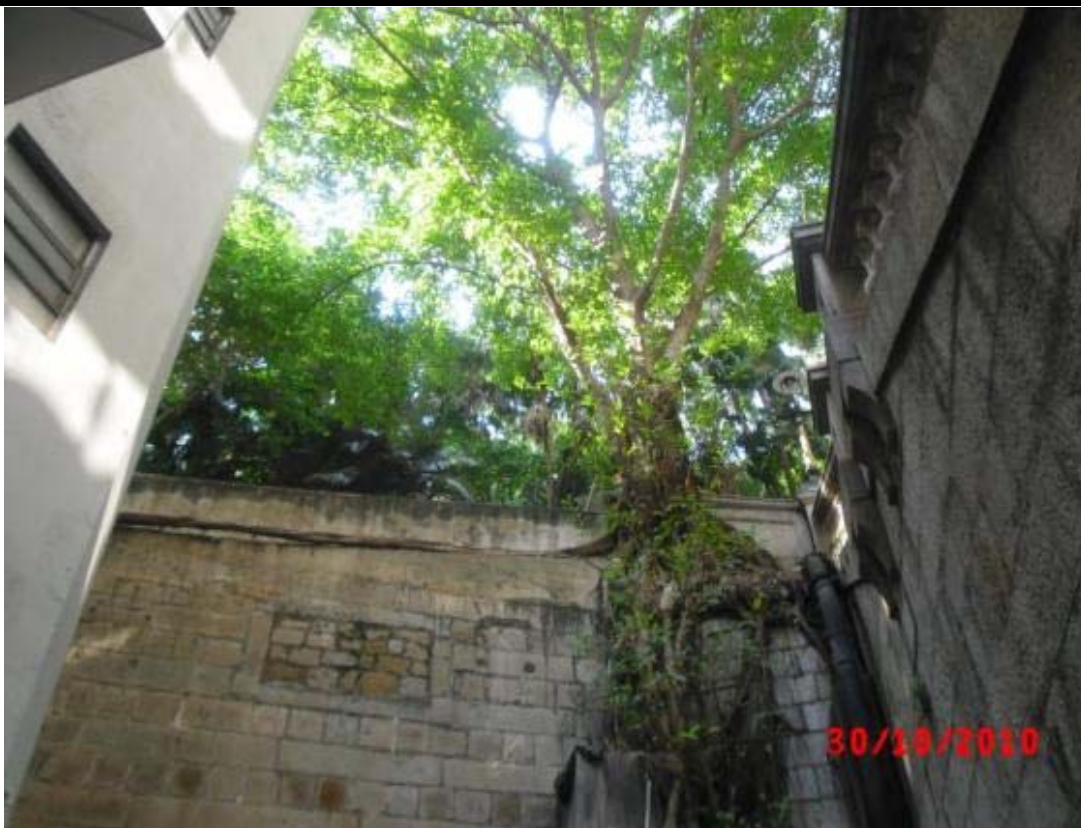
Subject Existing wall trees at the south-western side (Plate 81) **Date photograph taken** 30-Oct-10

Description View showing the existing conditions of wall tree at the south-western side of the Feature

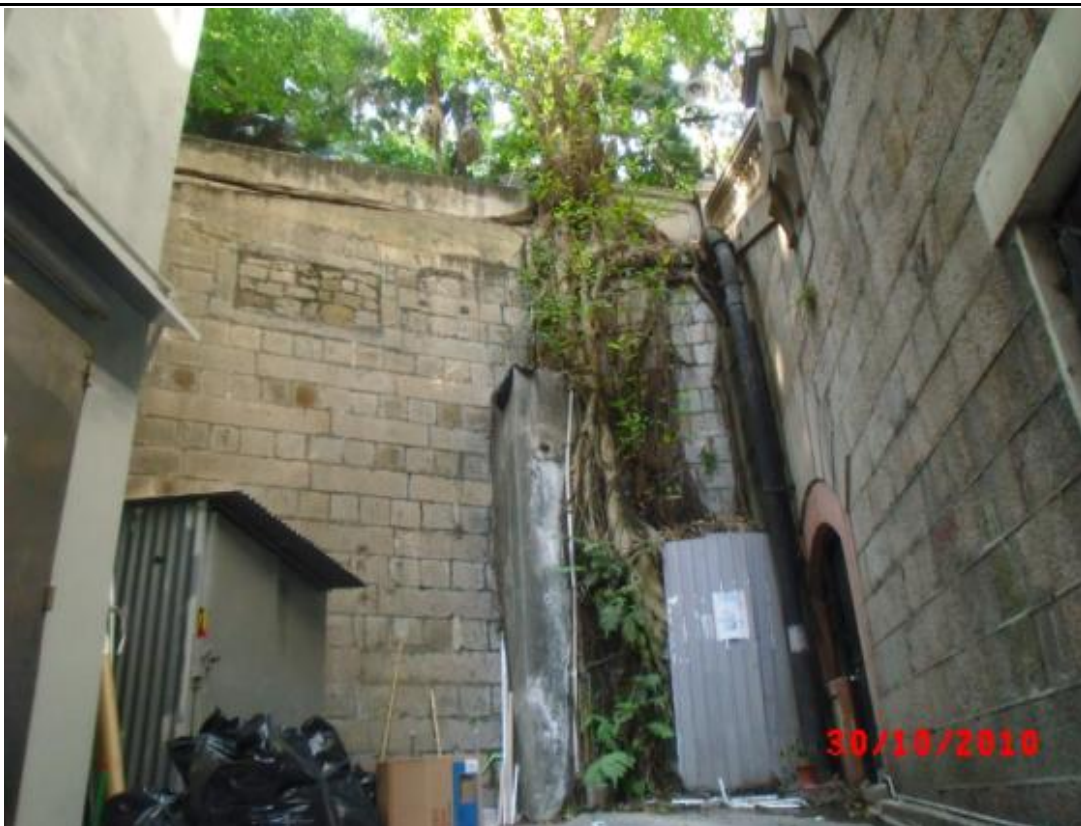
Subject Existing wall trees at the south-western side (Plate 82) **Date photograph taken** 30-Oct-10

Description View showing the existing conditions of wall tree at the south-western side of the Feature

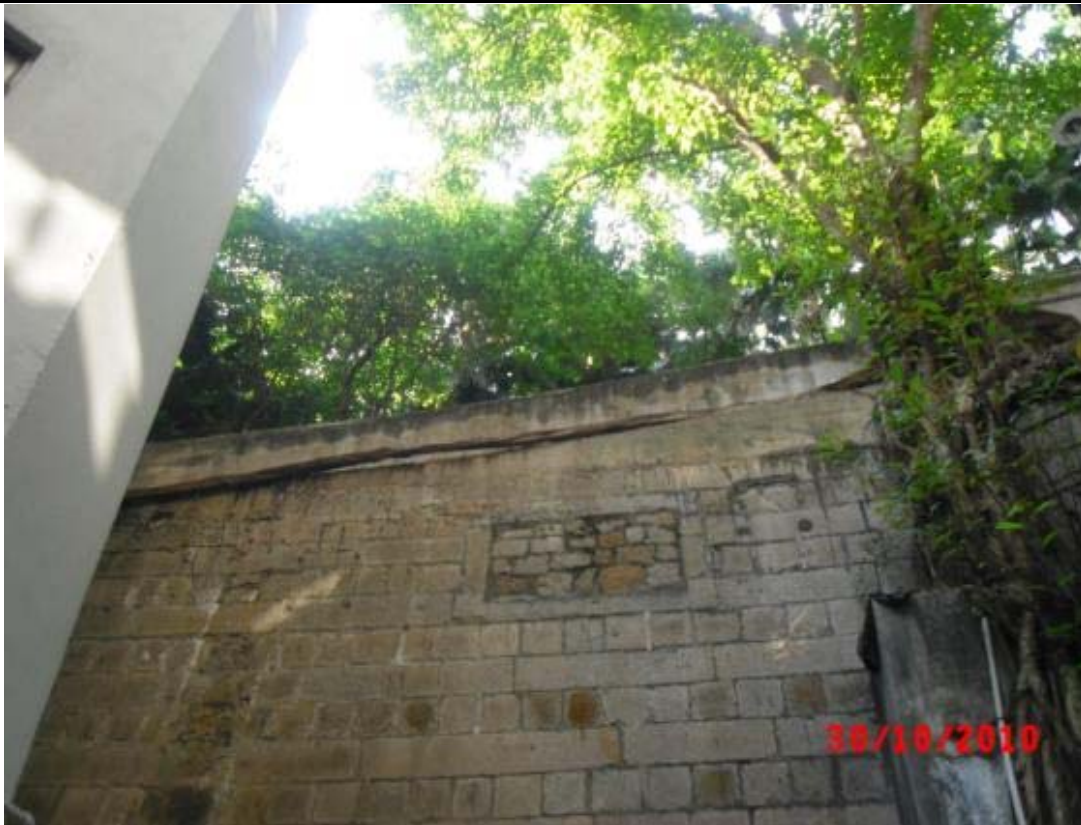
Subject Existing wall trees at the south-western side (Plate 83) **Date photograph taken** 30-Oct-10

Description Tree roots are extended to the Hong Kong Diamond Exchange Building

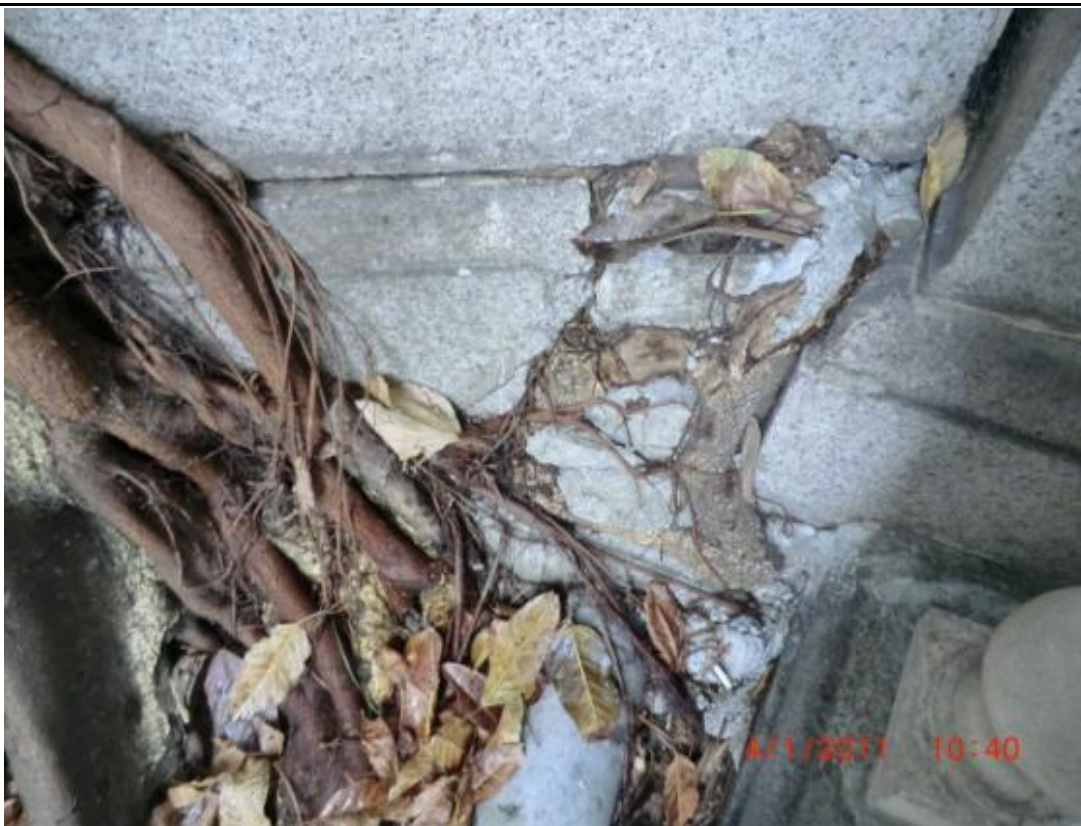
Subject Existing wall trees at the south-western side (Plate 84) **Date photograph taken** 04-Jan-11

Description Apparent cracks formed by the tree is observed at the south-western parapet wall
